# **Repair and Reinforcement of Glulam Beams for Tinora High School**

Gary W. Gray, PE  
Owner and Principal  
Gray Engineering and Design, LLC  
London, Kentucky USA

Paul C. Gilham, PE  
Chief Engineer  
Western Wood Structures, Inc.  
Tualatin Oregon USA

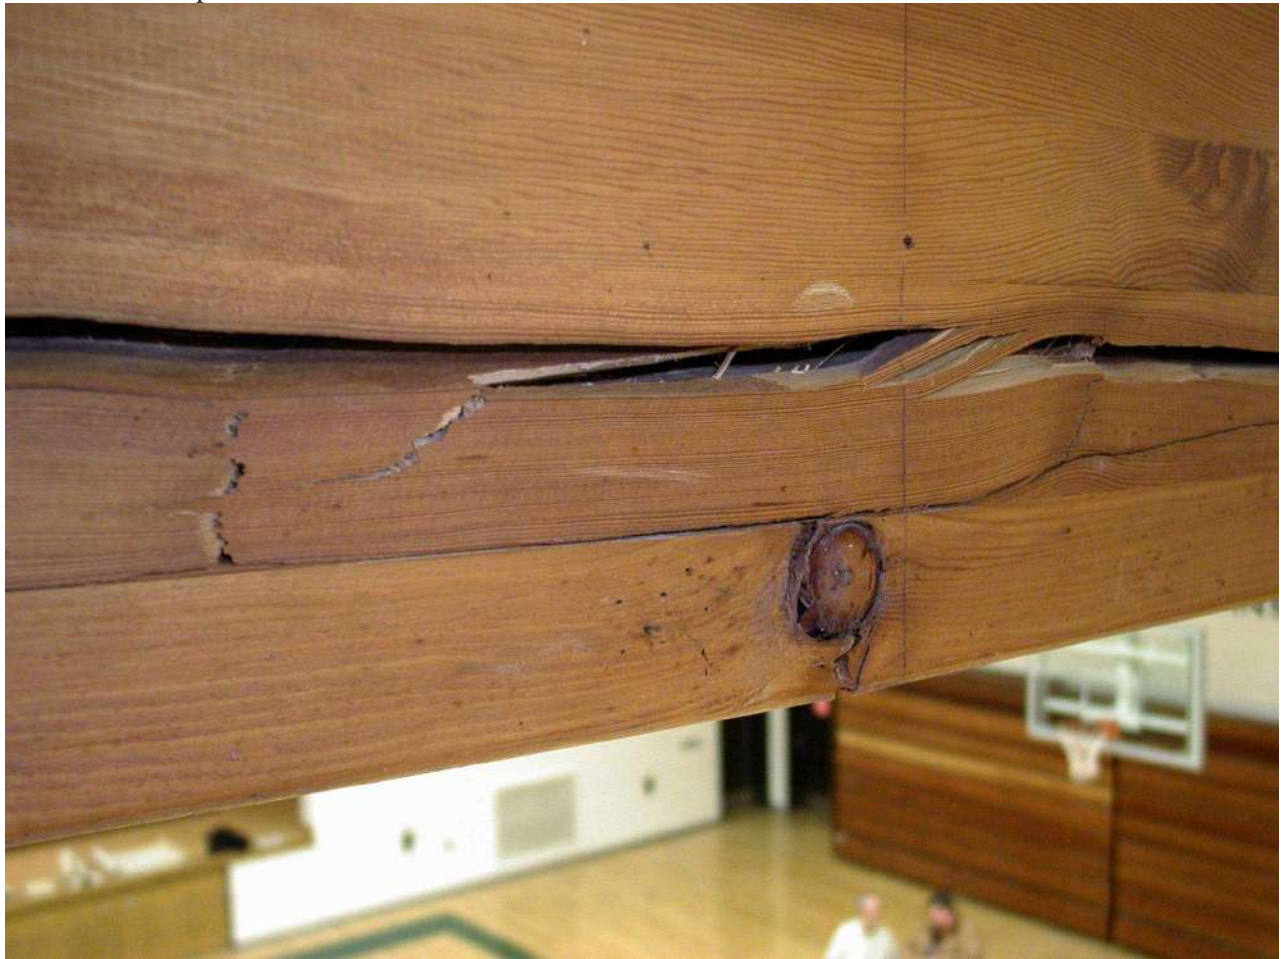
Figure 1. Failed beam due to overstress in bending.

The failure had initiated at a knot near mid-span at the bottom lamination and the crack had propagated upward and outward in a flat “V” pattern which is a classic type bending failure in wood beams. (See Figure 1) The crack had propagated up from the bottom face of the beam approximately 300mm at the time of the structural investigation. The beam had deflected approximately 76mm lower than the adjacent beams and the open crack at the failure zone was approximately 20mm wide and completely through the full width of the beam. The undamaged portion of the beam above the damage maintained enough structural integrity to prevent a catastrophic collapse of the beam. Inspection of the masonry walls at the beam bearing locations revealed no signs of distress due to horizontal displacements resulting from the beam failure.

Prior to the structural investigation, the owner had placed a temporary column support at the center span of the beam, but it was determined that the support was not adequate to safely shore up the beam. It was recommended that the beam be adequately shored up using two 150x150x6 HSS steel columns to prevent any further damage to the beam and to safe guard against a beam collapse. These two temporary supports were located symmetrically 2.74m from the center of the beam to allow for direct access to the bottom of the beam at the failure zone for possible repair applications.

Due to the significant loss of capacity of the failed beam and the calculated overstress condition of the remaining beams, Gray Engineering and Design recommended a repair and reinforcement method which included shear dowel reinforcing and the addition of a post-tensioning system to be utilized for both the failed beam and the remaining beams.

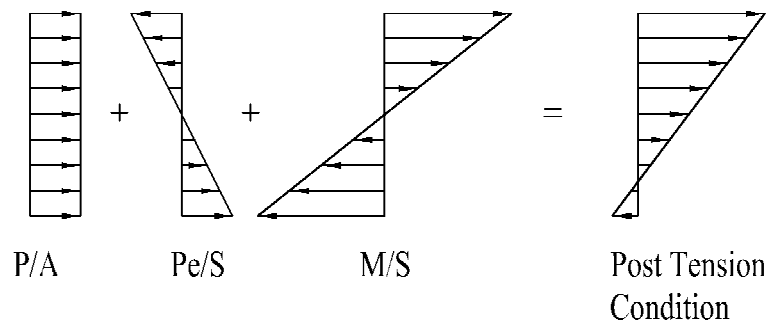
With a beam post-tensioning system, cables are installed on the beam soffit. A post-tensioning force is applied, which induces an eccentrically located compressive force to the beam. The eccentricity produces a bending moment in the member. Figure 2 shows the combination of the post tensioning stresses and the applied stresses. The  $P/A$  compressive stresses and  $P_e/S$  bending stresses are due to the cable tensioning. The  $M/S$  bending stress is in the opposite sense of the cable stresses and is due to the applied dead and live loads. The resulting tensile stress at the bottom of the beam in the post tension condition must be less than the allowable tensile stress of the member.

Figure 2. Combination of stress with post-tensioned system.

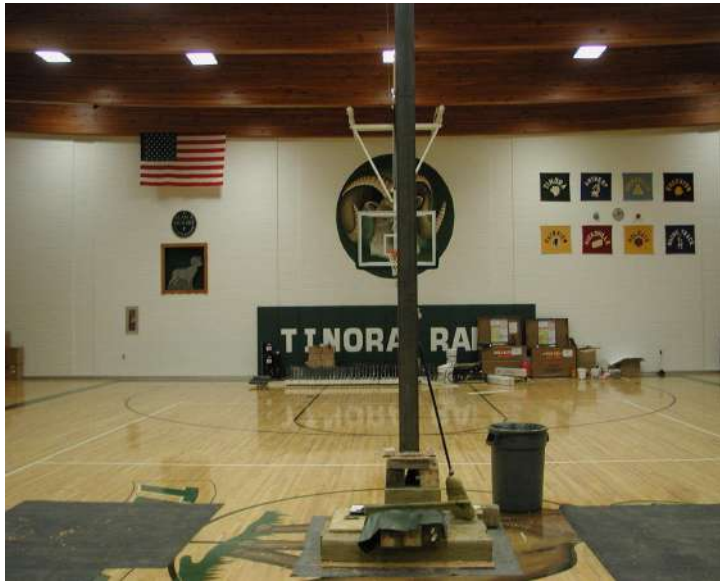
Figure 3. 152 x 152 HSS member used to jack beam to unloaded position during beam repair.

1. The beams were jacked up to approximately an unloaded position. A 152 x 152 x 6 HSS was installed on timber cribbing with a 20 ton bottle jack at the base. The jack was used to close the cracks as much as possible. See Figure 3.
2. 35mm holes were drilled vertically in the beam from the soffit to a point 152mm above the highest crack. See Figure 4.
3. Small port holes are drilled near the bottom of the beam and just below the top of the vertical hole
4. The sides of the beam were sealed with an epoxy paste. The epoxy used in the shear dowels has a very low viscosity and if

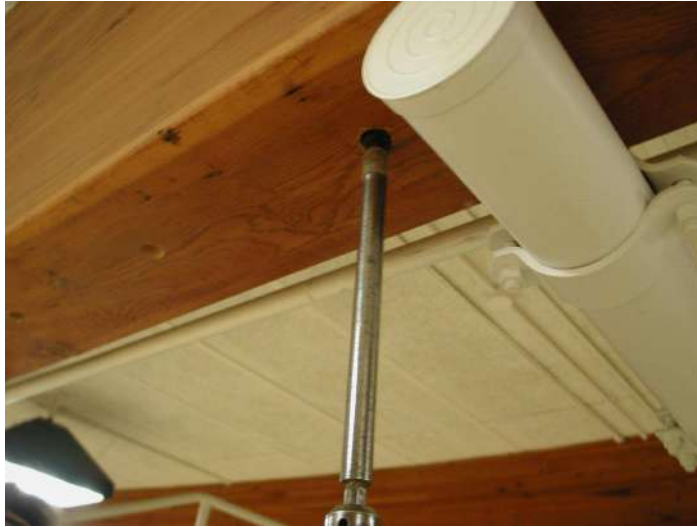
Figure 4. Holes drilled to receive Shear Dowels.

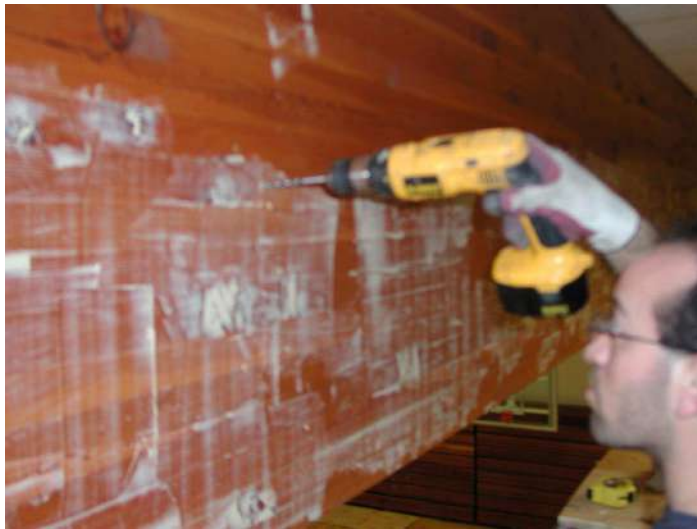
Figure 5. Drilling the injection and exhaust ports. Epoxy paste is used to seal the sides of the beam.

possible will travel along a void in a beam to the closest opening where it will run out. Sealing the sides of the beam prevented the liquid epoxy from leaking out of the beam.

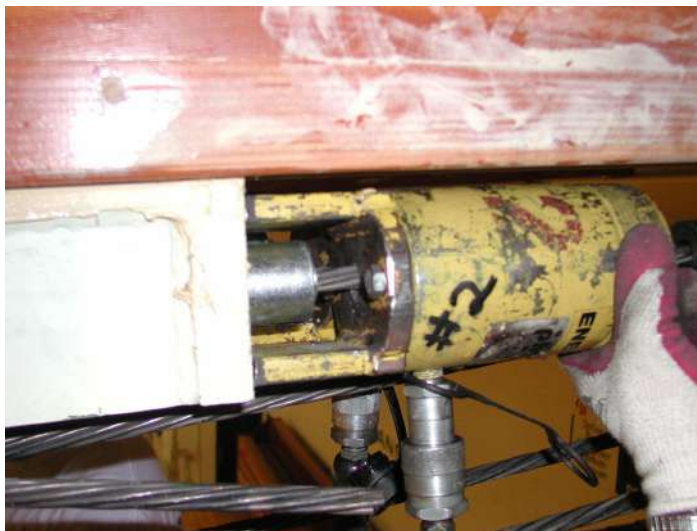
Figure 6. Cables are post-tensioned with hydraulic jack.

7. The cables are installed into the jacking assemblies and tensioned. This process begins with the innermost cables and continues outward. Five pairs of cables are required to supply the required negative moment and compression. Calibrated hydraulic jacks are used to apply the tension to the cables. See Figure 6.

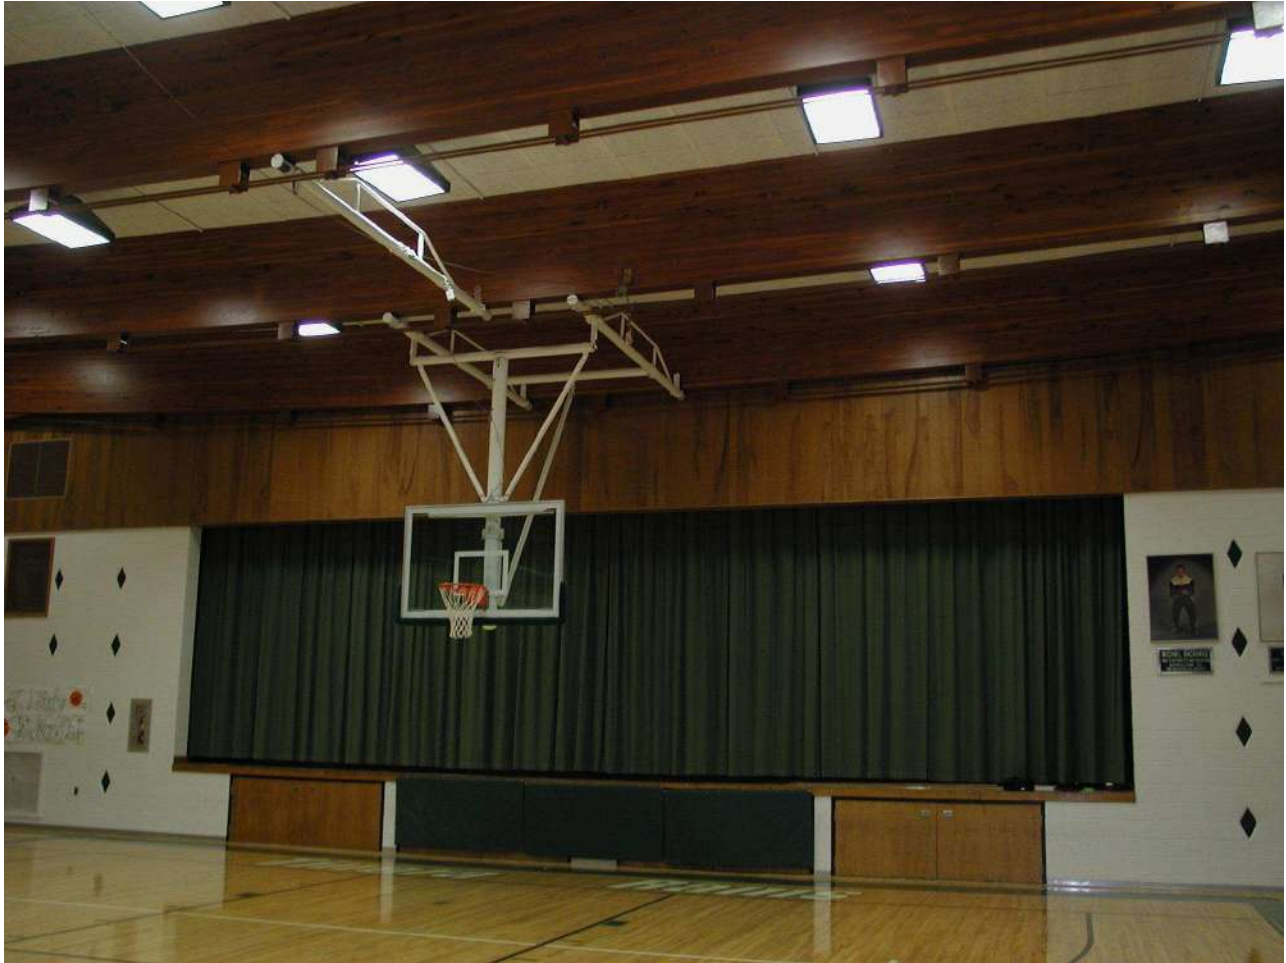
Figure 7. Completed repair/reinforcement of glulam girder beams.

8. With the structural repairs completed, the owner hired a finish painter to stain the beams and blend the new color into the existing color. Neither the epoxy paste or the plugs are noticeable from the floor.
