Impact and Assessment of Moisture-affected Timber-framed Construction

WoodSolutions Technical Design Guides

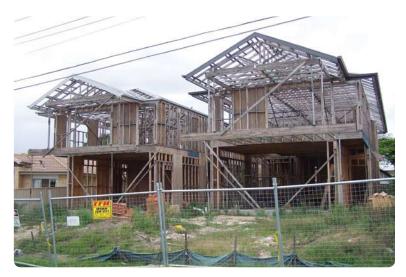
Timber frames exposed to the weather for six months.

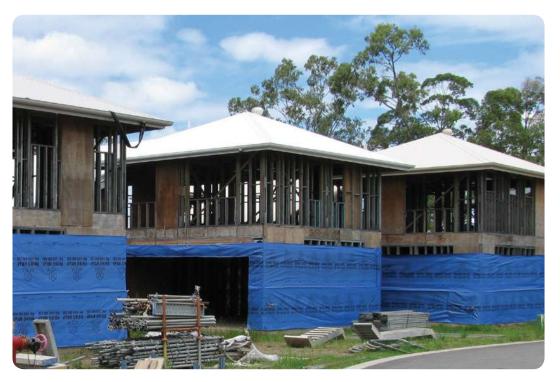
Exposed timber can become discolored and stained.

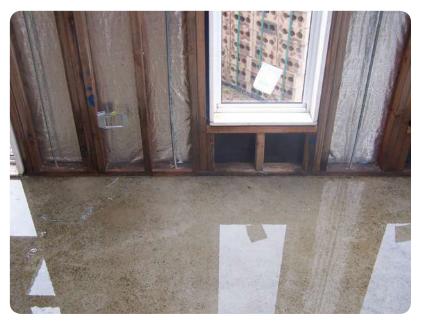
Water ponding on slab. Note wicking of moisture up the studs.

The areas of a weather-exposed frame likely to have the highest moisture content are bottom plates on slabs or sheet floors and the lower ends of studs on these plates due to wicking action.

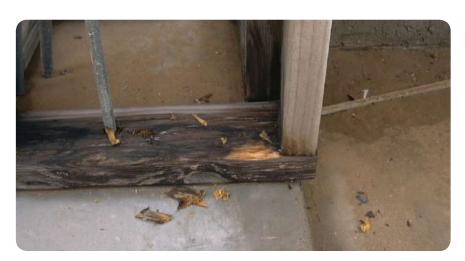
Significant discolouration due to stain but timber under surface is unaffected, with no decay.

Unprotected timber exposed to the weather can show considerable discolouration (white chalky look, through to very dark blue stains) due to moulds and stains. These moulds and stains 'live' on the sugars and starches naturally present in the timber, particularly in sapwood. In all but extreme circumstances, they do not affect the mechanical or strength properties of the timber.

Their impact can be easily established by scraping back the timber surface. Where the timber just below the surface is similar to 'fresh' timber, there will have been negligible or no deterioration.

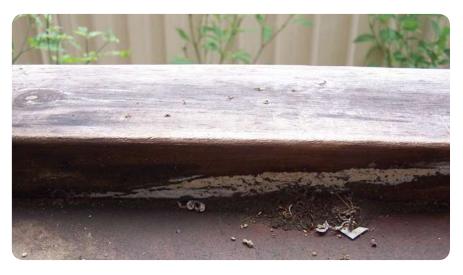
Decay in bottom plate on particleboard floor. Note small drill holes on top of plate used to detect decay.

Drilling using a fine auger or drill bit enables assessment deeper into the timber. Again, for the equipment being used, the force required to penetrate sound timber should be compared to the force required to penetrate affected timber. Timber that has decayed will be far more easily penetrated.

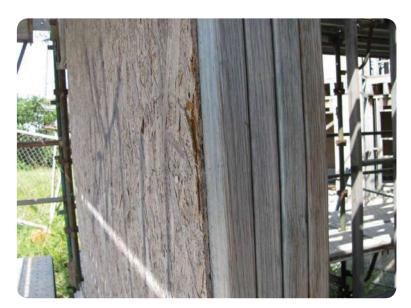
Example of OSB sheet bracing showing edge swelling and flaking.

Sheet edges are critical areas for evaluation.

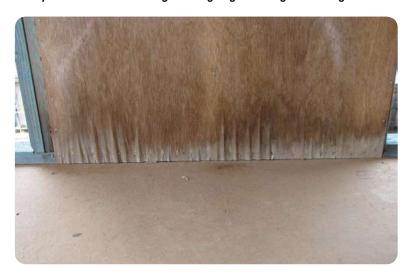
Plywood delamination at bottom plate in bracing panel. Note: The plywood used in the construction in the above example had no identification stamps or indication of certification schemes or Australian Standard for its manufacture.

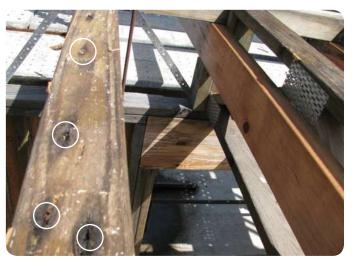
Decay pockets (highlighted) around fixing points where sheet flooring has been removed after 12 months' weather exposure.

Moisture can track down fittings into joists, creating local decay pockets.

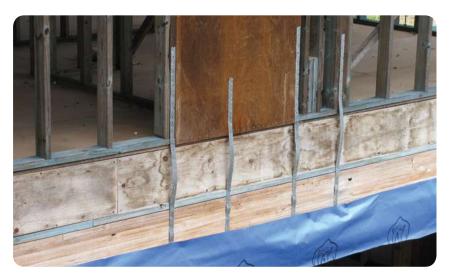
Loose tie-down steps due to timber expansion and then subsequent shrinkage.

As shown in the example below, the weather exposure of frames can cause connections such as straps and tie-down rods to become loose. This can be due to either minor frame settlement and/or wetting and expansion of the timbers and subsequent drying and shrinkage. These situations will not usually be due to degradation of the timber in the frames and can be easily rectified. They should not present any real structural concerns.

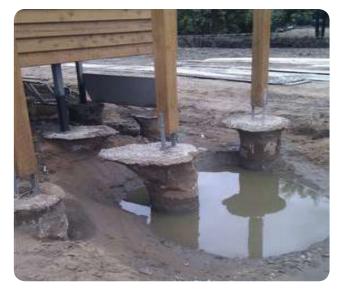
Footings scoured out by floodwaters (Image: BSA Queensland).

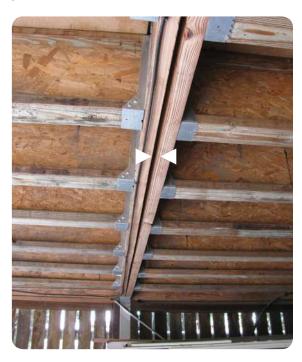
Expansion in flood-affected timber flooring.

Expansion of the hardwood T&G floor above has caused the separation of double bearers (see arrows).

Timber and wood-based products that have been saturated will swell. When they dry out, they will shrink. The amount of swelling or shrinkage depends on the type and species of timber or type of wood product, and the time exposed to water. Where timber has swollen in, for example, flooring, it may also have secondary effects such as cupping and pushing out external walls or movement of joists and bearers.

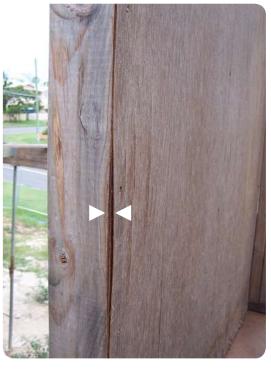
Delamination of plywood sheet bracing (see arrows).

Plywood sheet bracing affected by moisture. Replacement required. Where necessary fix temporary braces.

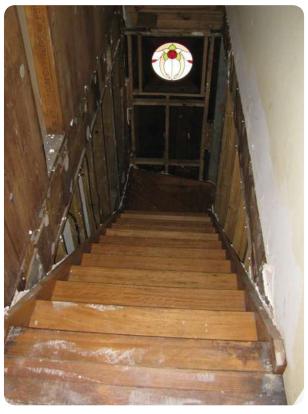
Solid timber stairs stripped out and allowed to dry were recovered following inundation.

Solid timber stairs can usually be recovered after inundation if surface material are removed quickly.

Stairs constructed from solid timber (hardwood or softwood), glued-laminated timber or structural plywood can usually be recovered provided any surface materials, such as carpet, attached to the underlying stair structure are removed, and the stairs are allowed to dry quickly. Because of their nature, with many housed joints, etc, forced mechanical ventilation or dehumification may be required to enable timely drying of the stair system.

After the stair structure has been allowed to dry, liberal application of a PVA or similar wood adhesive glue between risers, treads, end of treads, etc, and nailing with small diameter c-brads to help minimise splitting, will further stiffen and help reduce squeaks. Further gluing /nailing of existing cleats can also be considered.

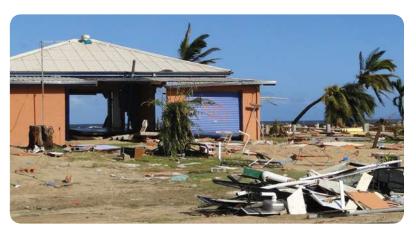
Storm surge damage to a slab on ground house. (Image: Cyclone Testing Station, James Cook University, Townsville)

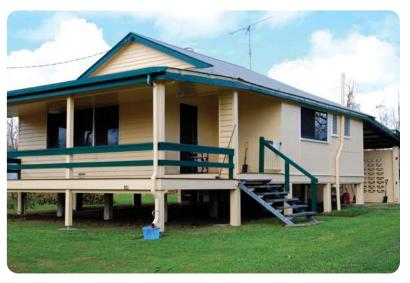
Elevated houses suffered little storm surge damage. (Image: Cyclone Testing Station, James Cook University, Townsville)

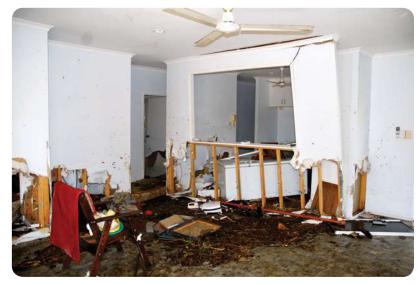
Storm surge structural damage. (Image: Cyclone Testing Station, James Cook University, Townsville)

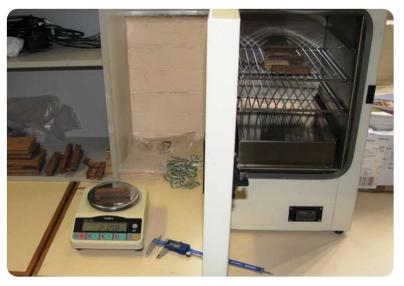
Oven dry moisture content measurement.

The equipment required is an accurate electronic digital scales (+/-0.2 grams) and a laboratory oven that is able to maintain a temperature of 103°C ± 2°C.

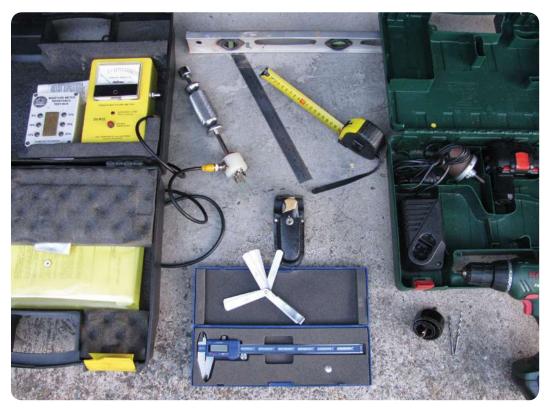
Typical range of site assessment tools.
